National Register of Historic Places  
Registration Form

historic name The Ellsworth Apartments  
other names/site number Parkview Homes. The Lee

street & number 928 Paseo Boulevard [ n/a ] not for publication  
city or town Kansas City [ n/a ] vicinity  
state Missouri code MO county Jackson code 095 zip code 64106

Apartment Buildings on the North End of The Paseo Boulevard in Kansas City, Missouri

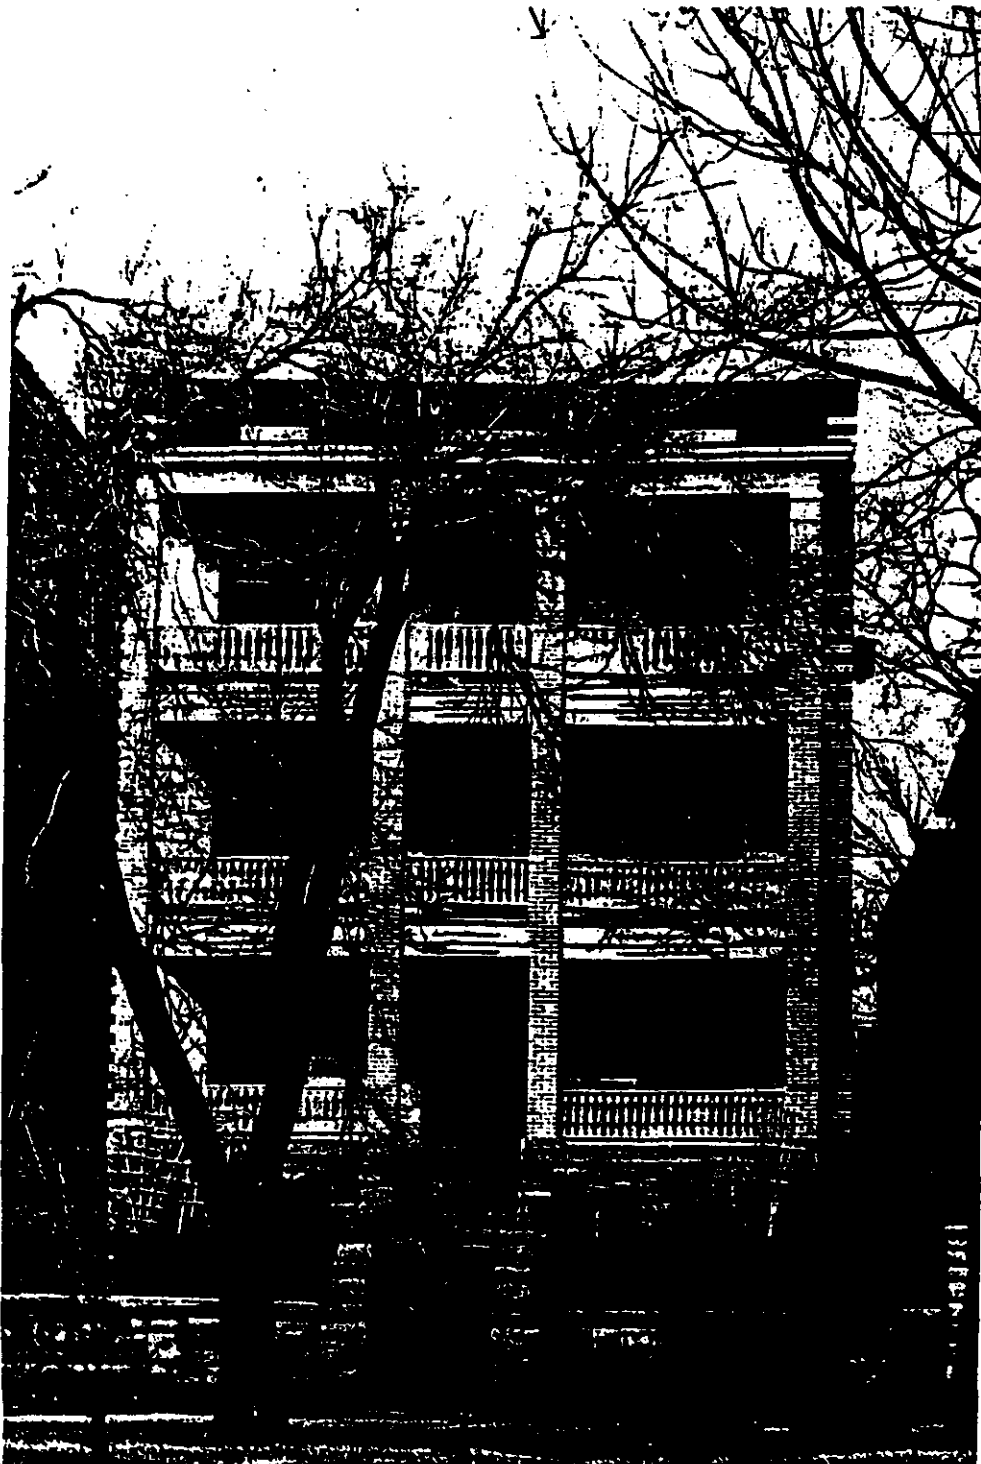
Figure 2. Photocopy of 1975 photograph of building, from 1975 drawings for HUD remodeling, William Johnson, architect

<u>Figure#</u>	<u>Description</u>
1	Survey
2	Photocopy of 1975 photograph of building Source: 1975 drawings for HUD remodeling, William Johnson, architect
